Surface Wrapper Intersects Itself

Caleb Kopitsky

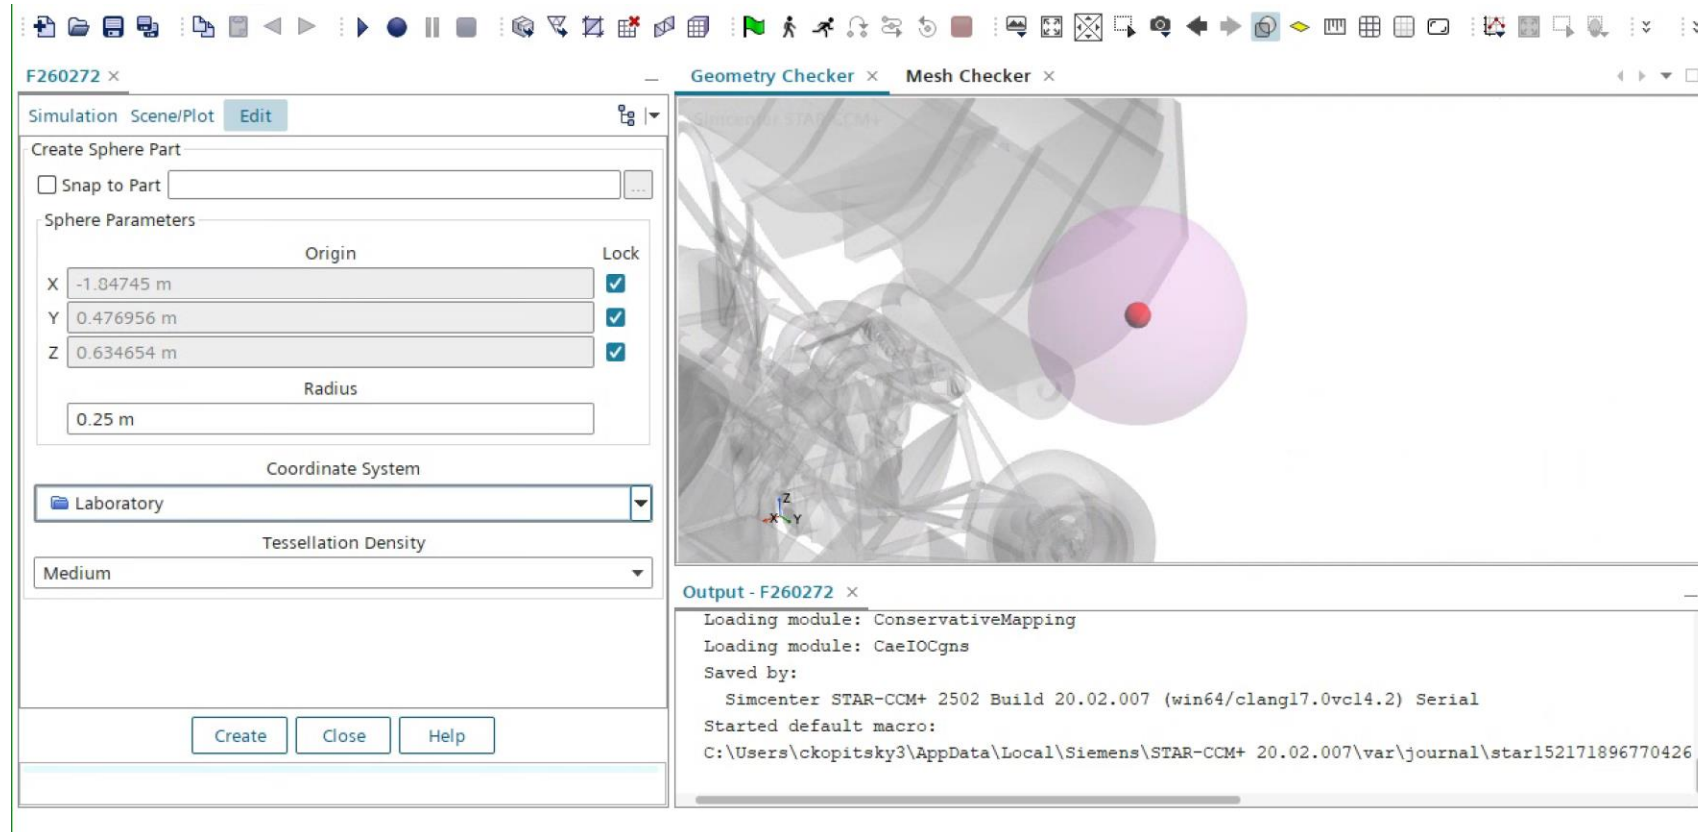
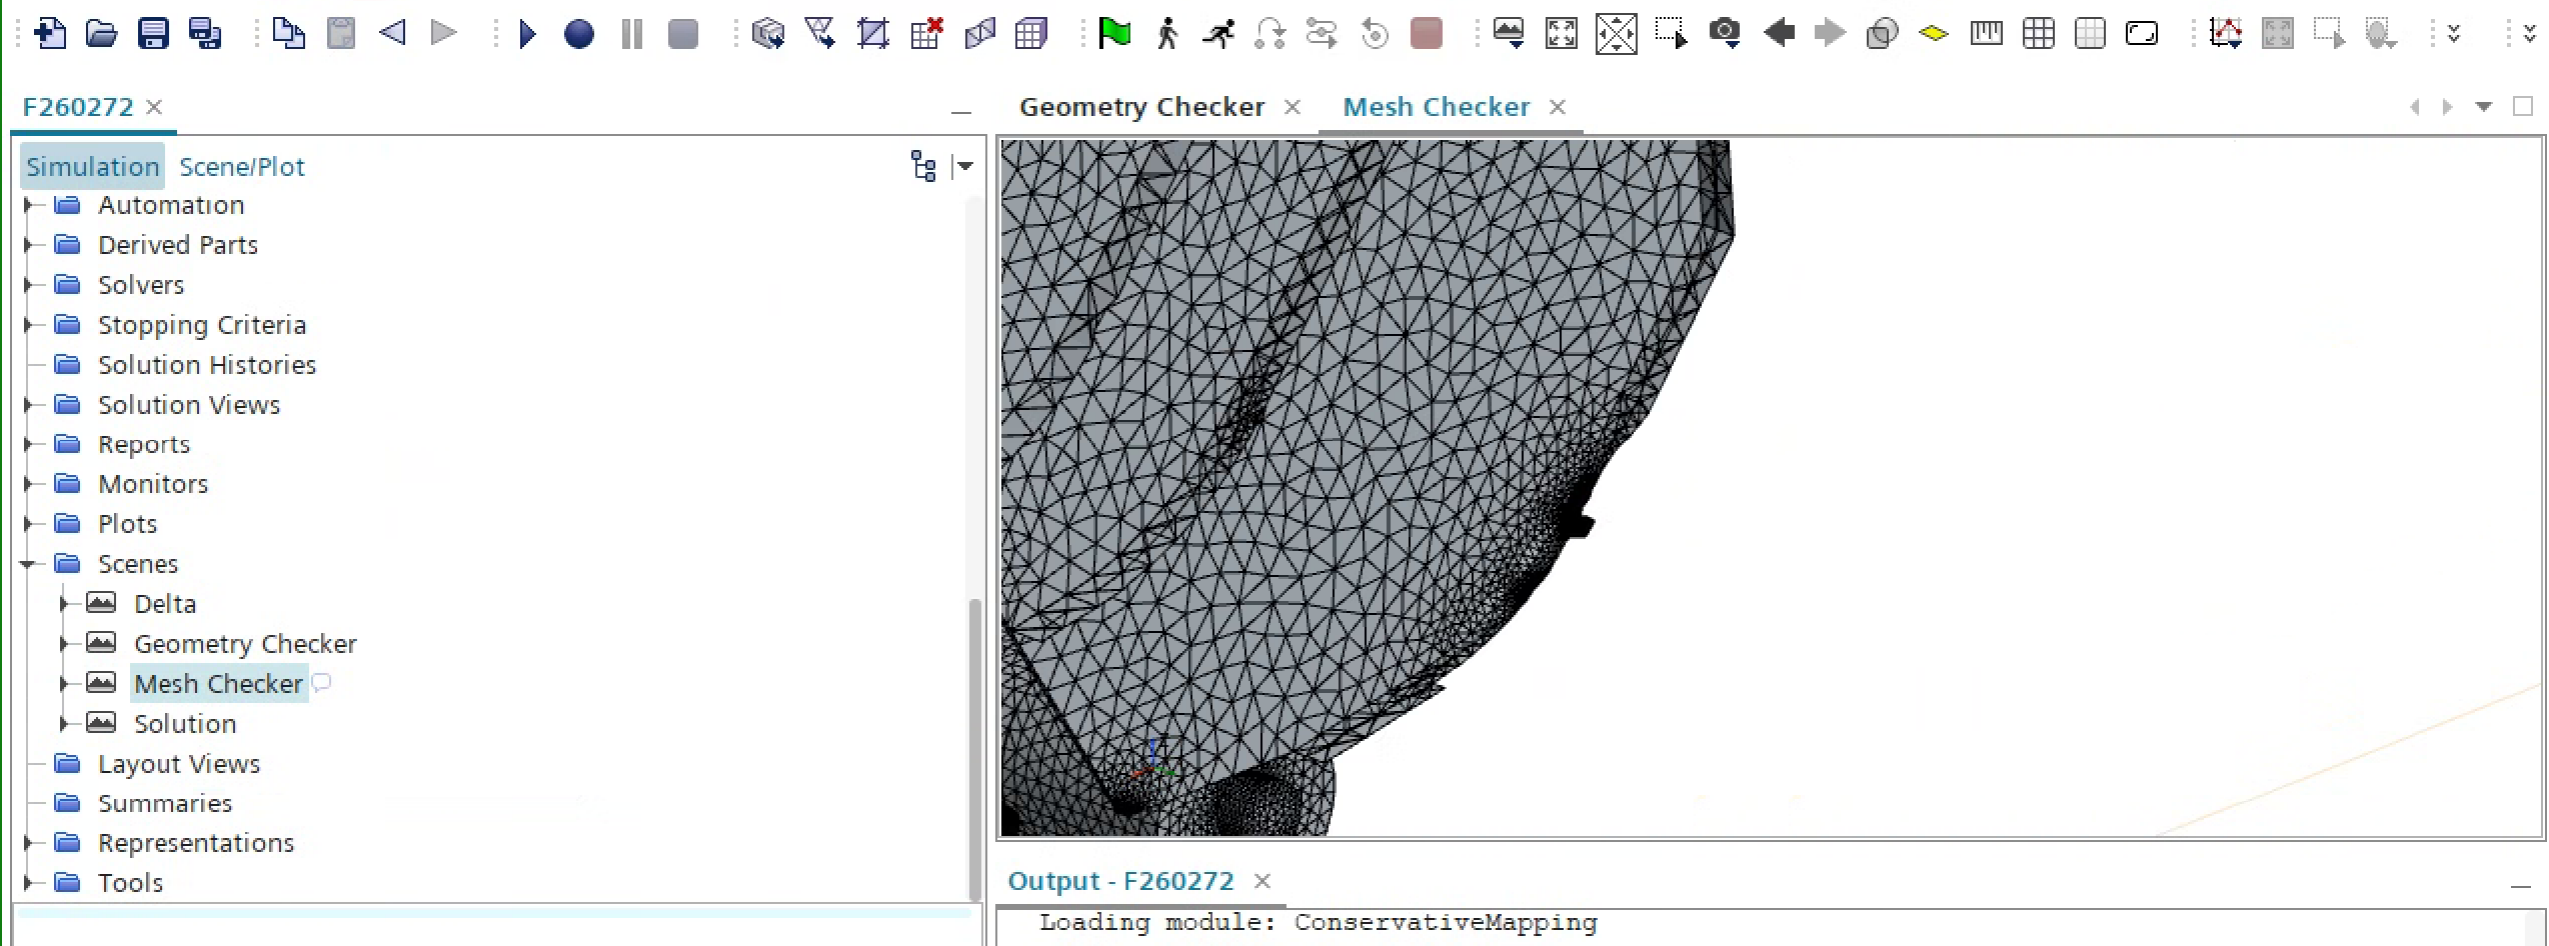
Input the coordinates from the Solve.out file (Hint: lock them so you do not accidentally drag the sphere). You can now easily see where the problem is occurring.

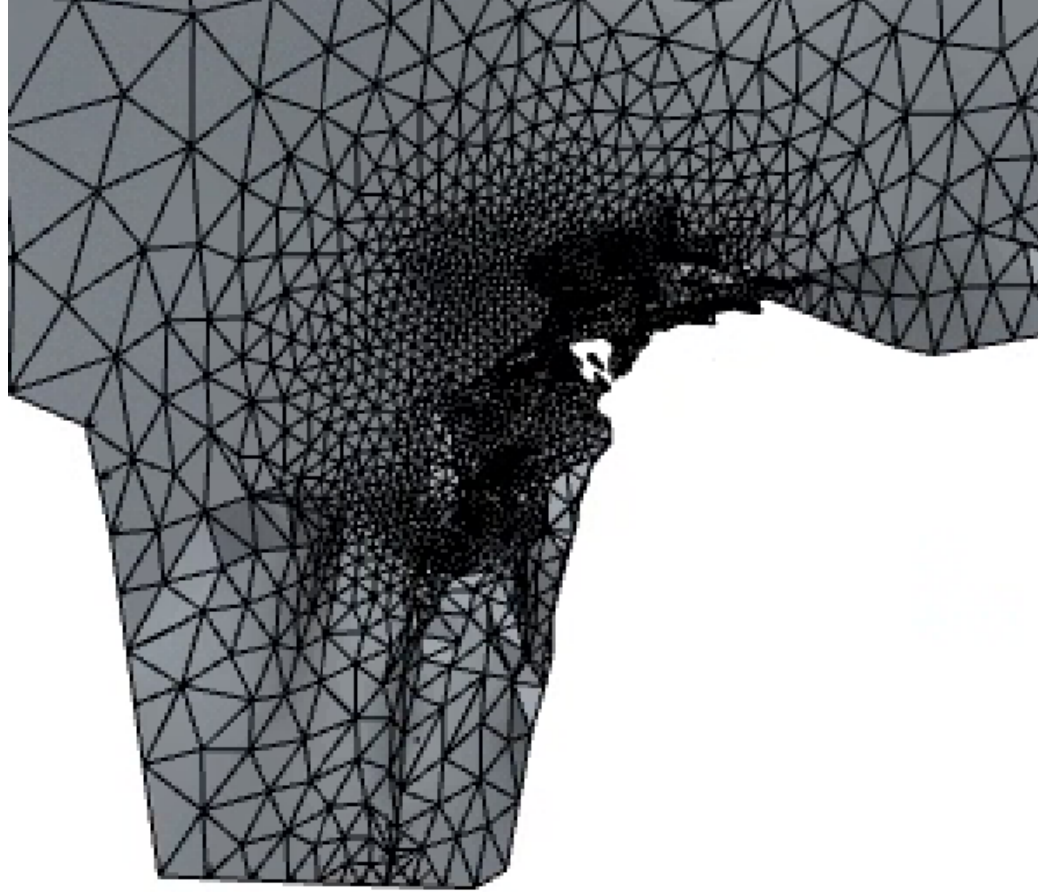
And here you can see the problem child in the mesh

Wow that's ugly

For this issue, there are two possible fixes:

1. Increase the mesh fidelity. The mesh settings for a part are defined under the part's surfaces (See how to run the sim queue). In this case, it was set to SW4 SM5 PL10, so increasing it to SW8 SM8 PL10 may be a solution
2. The part here is very thin ($<1\text{mm}$), so increasing the thickness may make meshing easier.

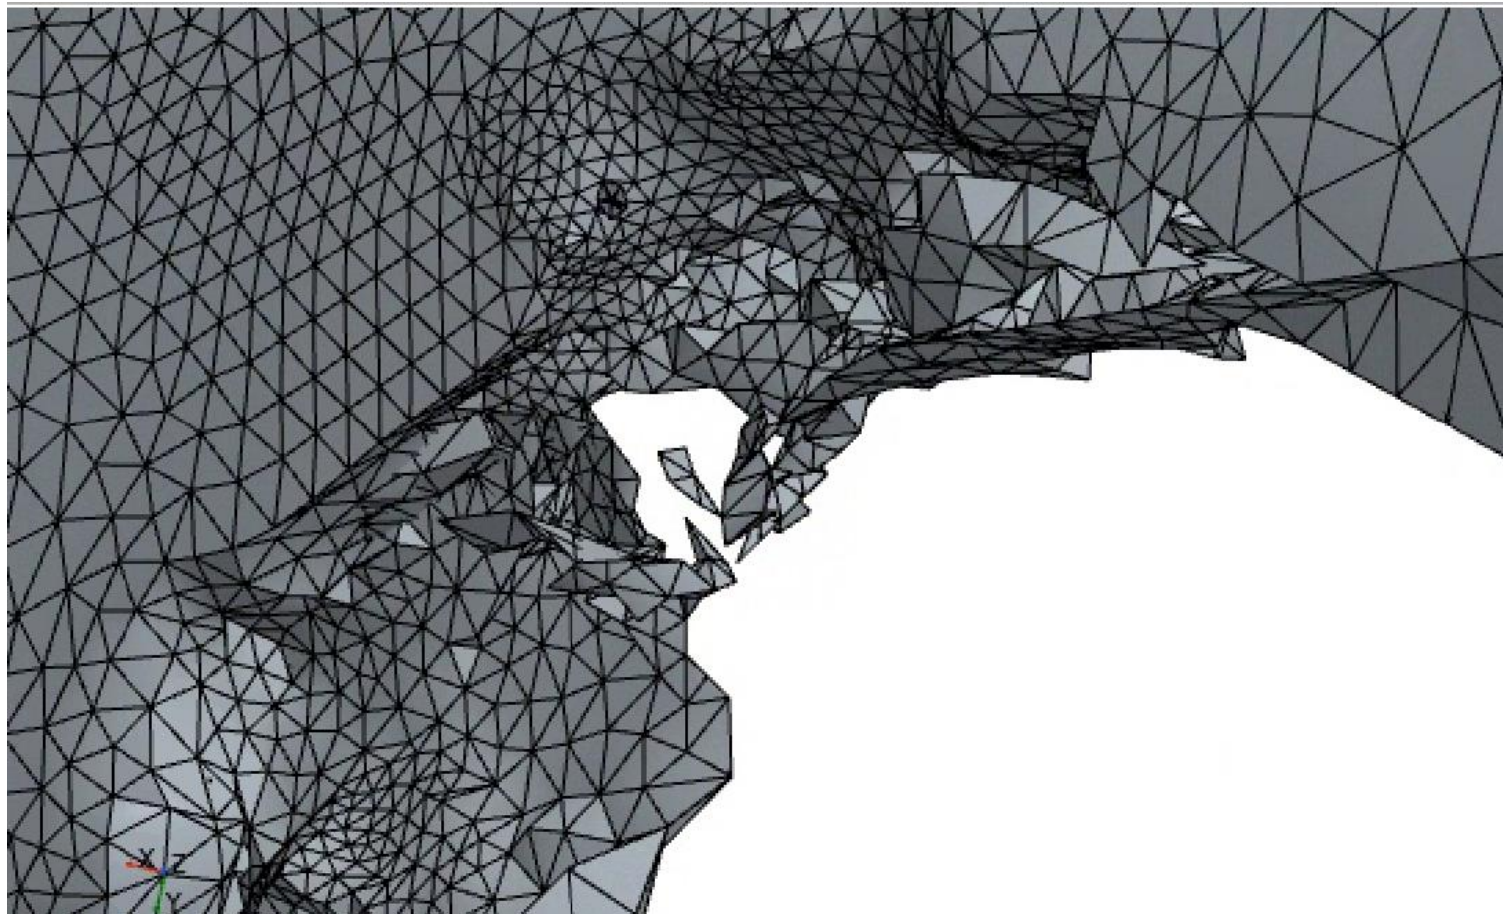
Impressively Ugly
